Manhole Inspection Summary

Manhole # S43I__012MH

Insp Date: **3/19/09 1:50 PM**

Location Address: **250 S BROADWAY**

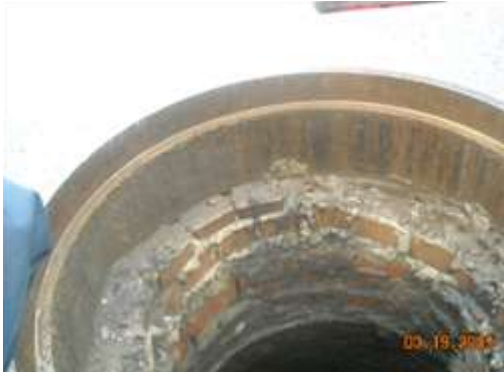
Defect 3

☐ Prev. Rehab Weather: **Heavy Rain** Subject To Ponding: **Sheeting**

INFLOW EVIDENCE FROM SHEETING

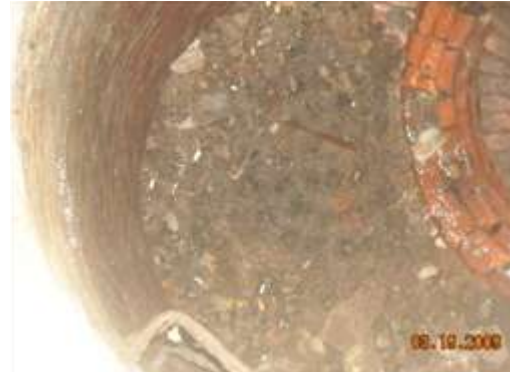
Defect 2

Condition: ☐ Sound ☐ Cracked ☐ Root Intrusion ☐ Deteriorated ☐ Leaks ☒ **Debris**

DEBRIS ON BENCH

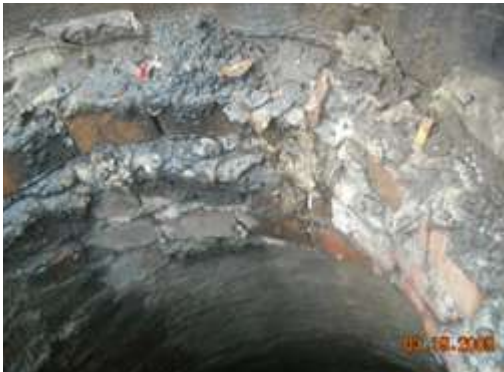
Defect 1

Infiltration: ☐ None ☒ **Joint** ☐ Cracks ☐ Mortar ☐ Roots ☐ Wall

INFILTRATION @ CHIMNEY/FRAME JOINT, DETERIORATING CHIMNEY

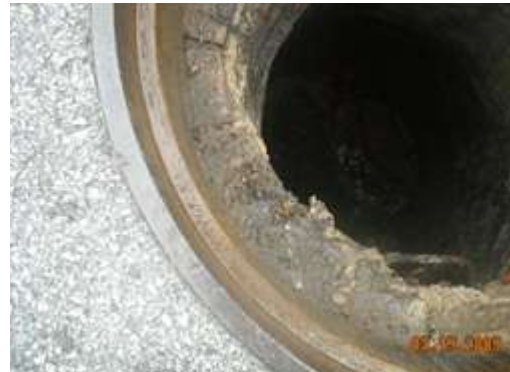
Frame Offset: **4** (in.) Condition: ☐ Sound ☐ Cracked ☒ **Leaks**

FRAME OFFSET

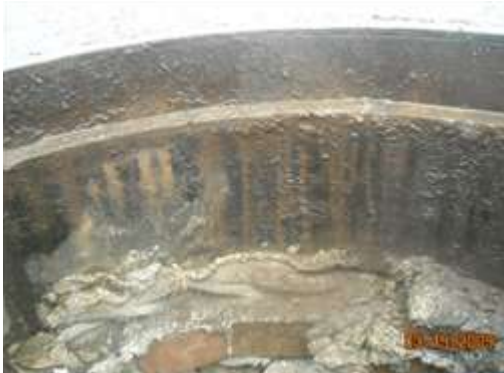
Defect 7

FRAME LEAKS

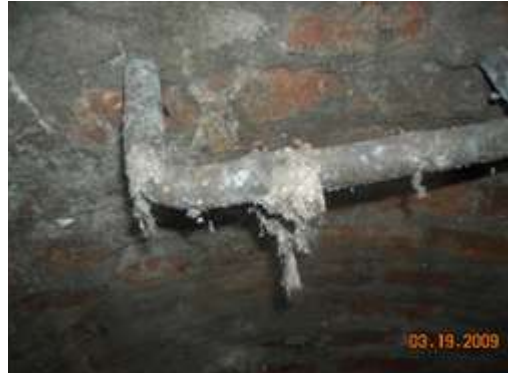
Defect 6

Surcharge ☒ **Evidence Of Surcharge** Depth: **4** (ft.) ☐ Active Surcharge Present

SURCHARGE EVIDENCE

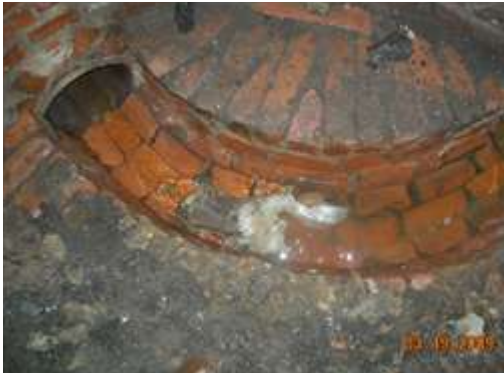
Defect 5

Condition: ☐ Sound ☐ Cracked ☐ Root Intrusion ☐ Deteriorated ☐ Leaks ☒ **Debris**

DEBRIS IN CHANNEL

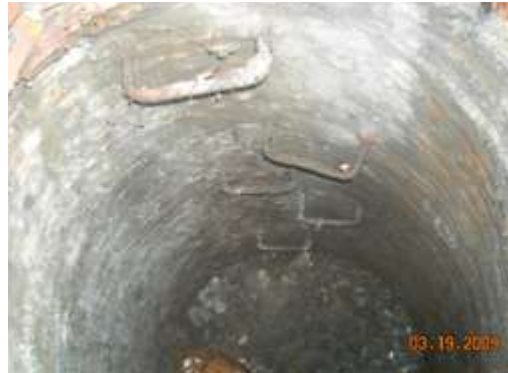
Defect 4

Steps Count: **5** Missing: **0** ☒ **Corroded**

CORRODED STEPS

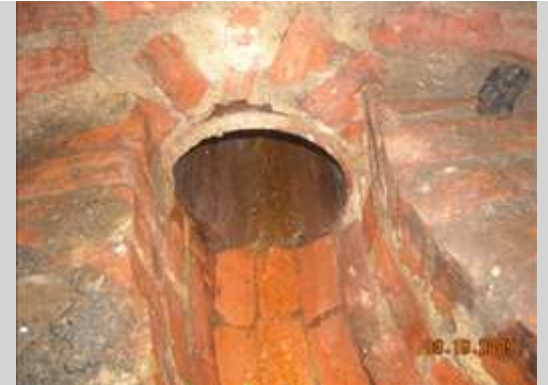
12 O'Clock Outflow

8 in. Circular Gravity Sewer
Pipe Out @ 12 O'Clock

Pipe Height: **8.4** (in.) Rod and Bar (Angled)
Pipe Material: **Clay** ☐ Pipe Lined
Invert Depth: **9.75** (ft.) Flow Characteristics: **Slow**
Deposits: ☒ None ☐ Mud ☐ Sludge ☐ Debris ☐ Grease
Silt Depth: **0** (in.) Deposits Extent:
Infiltration: **None** Pipe Seal Cond: **Sound**

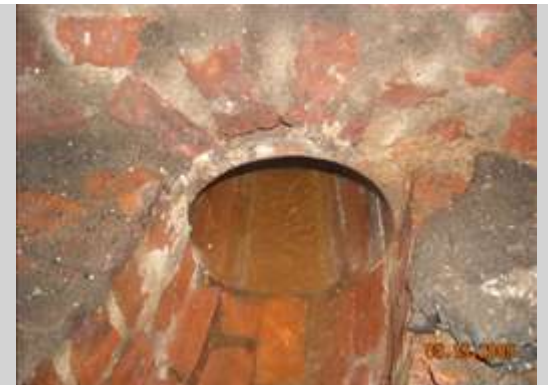
3 O'Clock Inflow

8 in. Circular Gravity Sewer
Pipe In @ 3 O'Clock

Pipe Height: **8.4** (in.) Rod and Bar (Angled)
Pipe Material: **Clay** ☐ Pipe Lined
Invert Depth: **9.67** (ft.) Flow Characteristics: **Slow**
Deposits: ☒ None ☐ Mud ☐ Sludge ☐ Debris ☐ Grease
Silt Depth: **0** (in.) Deposits Extent:
Infiltration: **None** Pipe Seal Cond: **Sound**
